JIMMERSON LAKE DIAGNOSTIC STUDY

**A Lake and River Enhancement Project
funded by the Indiana Department of Natural Resources
Division of Soil Conservation
Indianapolis IN**

**For the Jimmerson Lake Association
Angola, Indiana**

Submitted: January 2003

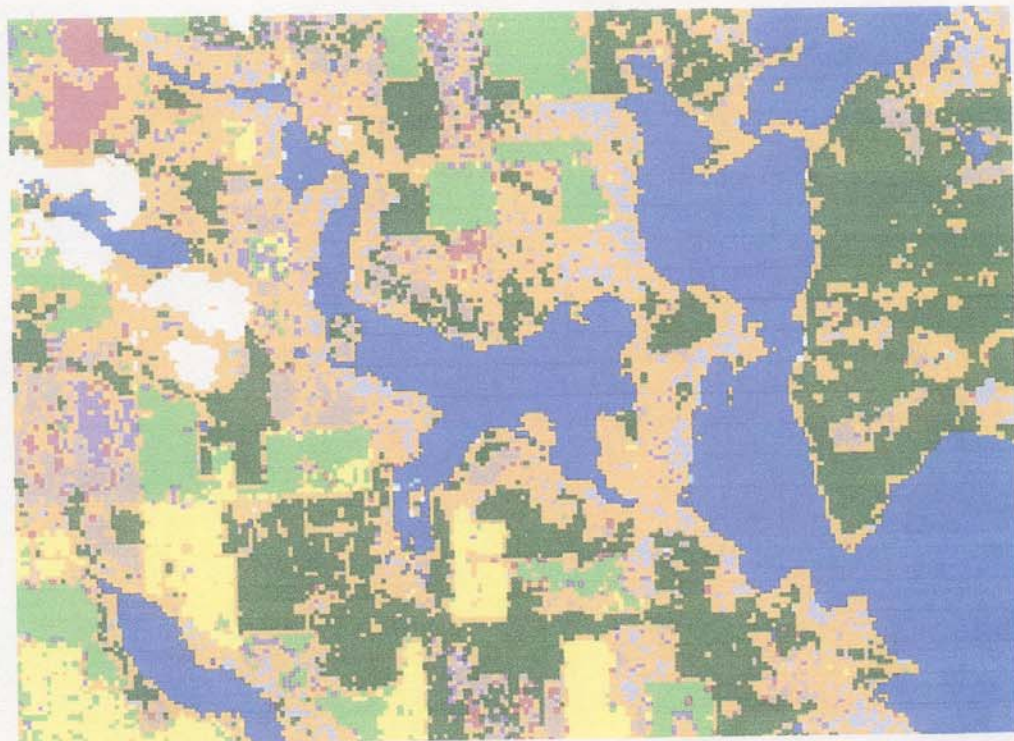
Fig. 6. Watershed land use

Land uses, obtained from a satellite photograph of the area in the summer of 2000 (National Agricultural Statistics Service), are shown in Figure 6. Nearly 90% of the land use in the watershed is agricultural, including livestock production, row crop agriculture, and pasture.

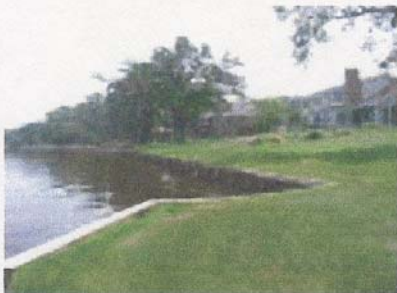
1. Construction of new concrete seawalls. A proliferation of concrete seawalls has been shown to have a detrimental effect on lakes [18]. Concrete seawalls deflect wave energy to adjacent properties, causing shoreline erosion elsewhere. They create a barrier for reptiles, amphibians and other species that must travel to and from water to feed or complete their life cycles. They produce a barren near-shore area devoid of most plant and insect life that fish and wildlife feed on. Concrete seawalls also detract from natural shoreline beauty.

Shoreline with seawall

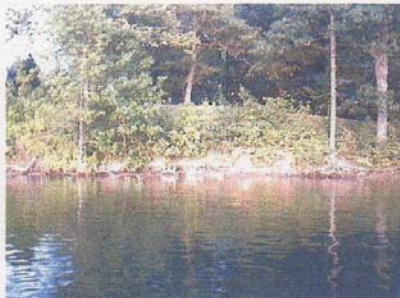
Natural shoreline

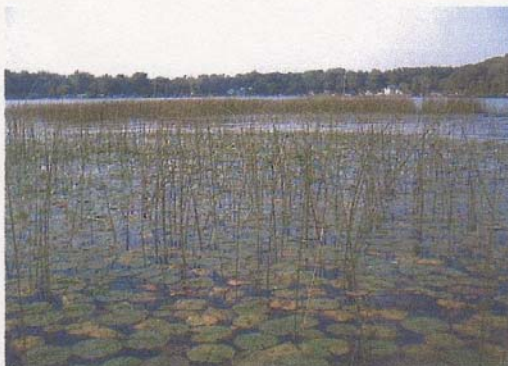
Fig. 12
Shallow areas with extensive plant beds are in yellow
Floating islands are marked in green
Blue areas indicate deep water with no plants

Aquatic plant beds in Jimmerson Lake occur in areas where water depth is less than 10 feet. Over half the lake is in this relatively shallow category. Most plant beds in the lake are in near-shore areas. However, there is also a bed of emergent wetland plants forming a small island in the middle of the lake. Local residents say this island's size has decreased by 50% in the past few years. Fig. 12 shows areas in the lake with aquatic plant beds.
